# Prioritizing Stream Segments for Riparian Restoration Projects

*2008 Report*

In five salmon-bearing streams in Seattle, WA

Submitted by:  
Gretchen Peterson, PetersonGIS  
19385 Schooner Court NE  
Poulsbo, WA 98370  
360.697.1170

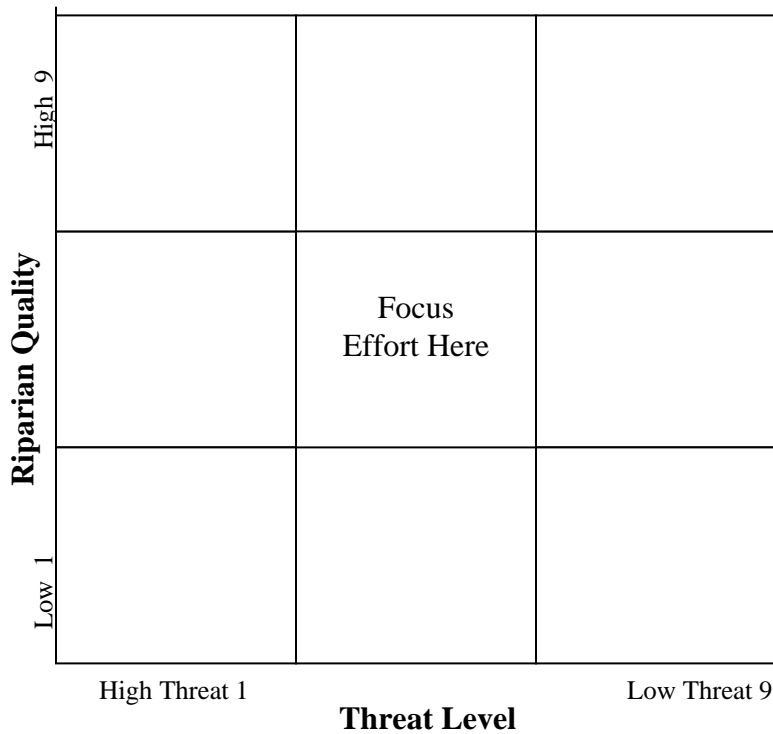
**Figure 1.** Modified quality/threat decision matrix

The quality/threat matrix used in this study was adapted from a similar one described in the Green Seattle Partnership's [20 Year Plan](#) (page 24). In this study, however, the matrix was modified, as shown in Figure 1.

The 1-9 scale was designed so that 1 indicates “poor” conditions and 9 indicates “good” conditions for salmon habitat. A medium threat level and medium riparian quality were considered high priorities for restoration projects. The exact mid-range (threat between 3 and 6 and quality between 3 and 6) box contained only 72 stream segments so the selection range was expanded somewhat (to 2.8 and 6.6, respectively) to enable the selection of at least 100 stream segments. It should be noted, however, that there are other methods of deciding which stream segments receive priority, especially depending on the specific outcome. A low threat, medium riparian quality may be just as important for restoration if many of the mid-range box segments contain threats that can not be changed.

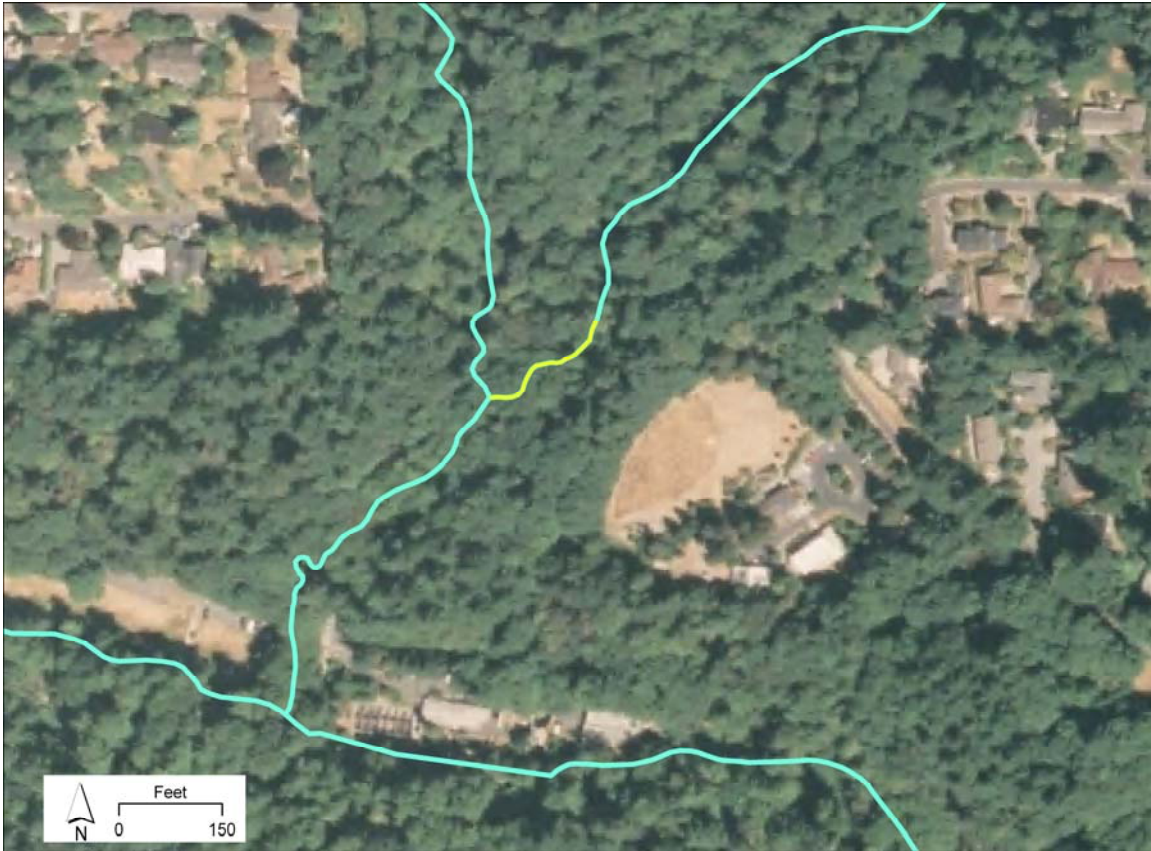
**Figure 3.** Pipers Creek, Venema tributary, final score of 9 for both quality and threats

One stream segment, on the Venema Tributary of Pipers Creek, got a score of 9 for both the quality and threat models. It is shown in figure 3.

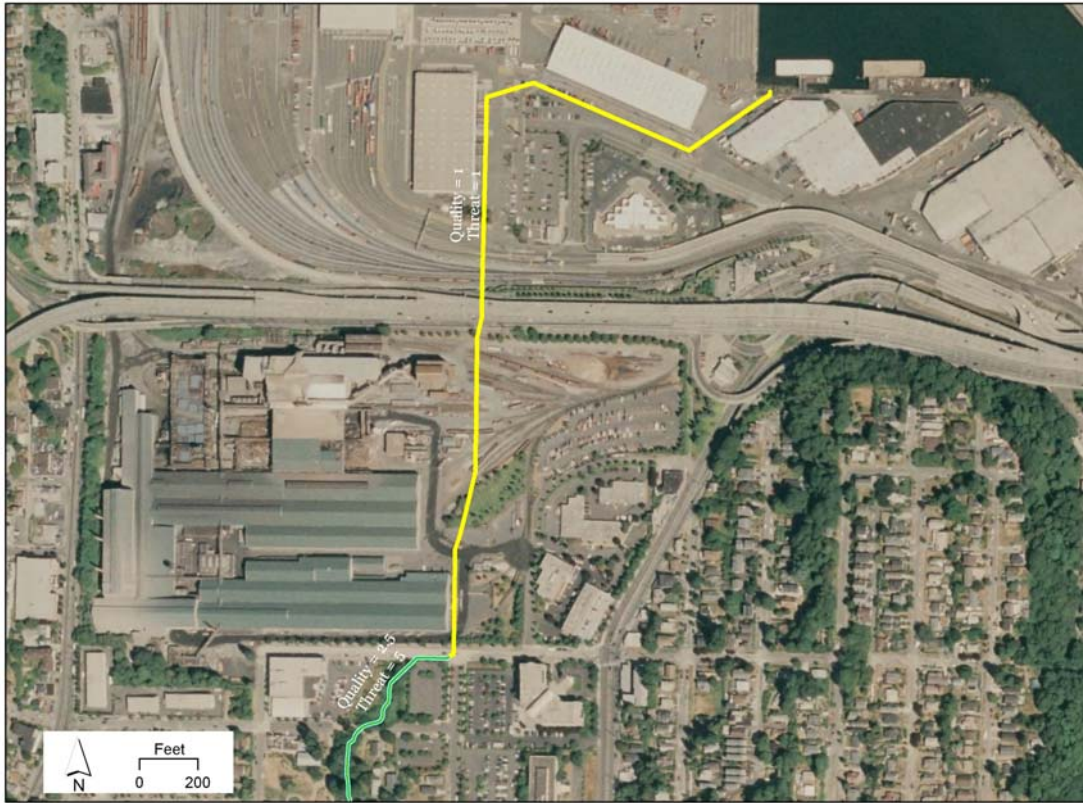
**Figure 4.** Longfellow Creek, Mainstem: final score of 1 for both quality and threats

There were 189 stream segments receiving the lowest scores, a 1 for quality and a 1 for threat. One of these segments, on the Longfellow Mainstem, is shown in Figure 4.
